Flightfax®

Online Report of Army Aircraft Mishaps

Mishap Review: Route Reconnaissance

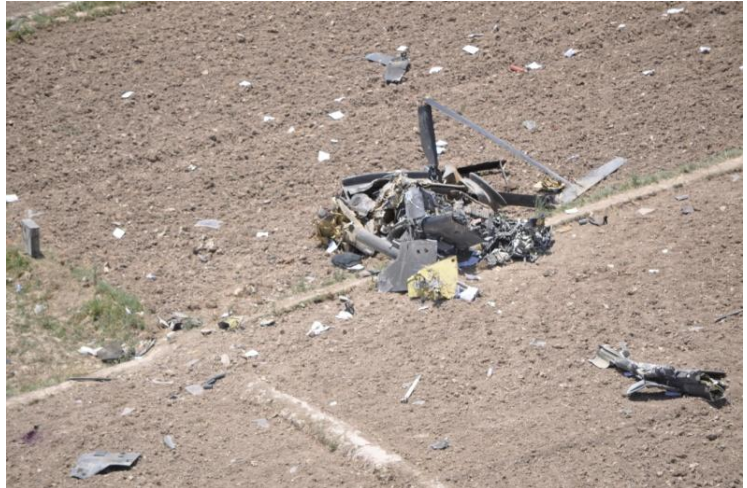
Approximately two and one-half minutes after receiving an Engine Chip Lower message, the OH-58D's engine failed. The aircraft entered autorotation and landed hard to an unimproved area causing significant aircraft damage and two major injuries.

The flight departed at 0900L with the accident aircraft in the lead position, flying approximately 200 feet AGL and the trail aircraft flying at 300 feet AGL. The first part of the mission proceeded as briefed. The flight returned an hour and a half later to re-fuel and departed at 1040 to resume the operation. At approximately 1047L, lead announced to trail that he had received a Chips Engine Lower message on his MFD. The decision was made to return to home base. At 1049L at 150 feet AGL and 90 knots airspeed, the engine failed. The crew executed an autorotation to a soft soiled plowed field surrounded by 6- to 8-inch berms. During the landing sequence, the aircraft struck a berm resulting in separation of the forward cross tubes and a left fuselage roll after contacting the ground. The aircraft was extensively damaged and the crew sustained serious injuries.

The accident board determined the accident aircraft engine sustained an in-flight engine failure. There was insufficient information to determine the type of failure and the engine was sent for tear-down analysis.
